**Canadian Heart Rhythm Society
Device Committee**

Re: St. Jude Medical Riata and Riata ST High Voltage Leads

CHRS Class of Advisory: Class I

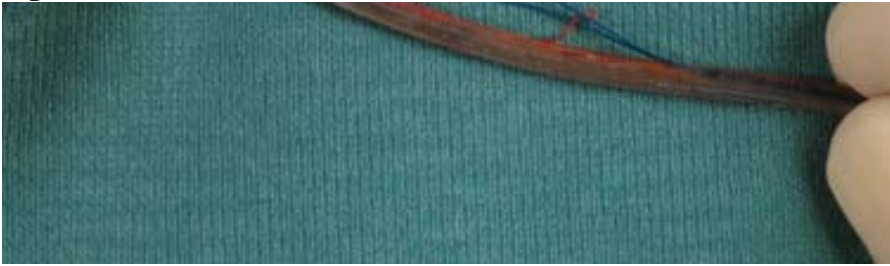
Nature of the Advisory: This advisory describes a unique form of lead failure in the Riata (8Fr) and Riata ST (7Fr) silicone endocardial defibrillation leads. This form of failure is due to an outer insulation breach resulting in externalization of conductor cables, contained within the body of the defibrillation lead. The breach results in the externalized conductors becoming visible on either X-ray or fluoroscopy outside the lead body. The cause of the insulation breach may be due to relative motion of the conductor cables within the lead insulation lumen, referred to as “inside-out” abrasion, or from external sources, such as lead-to-lead abrasion. The most common area of abrasion (75% of confirmed cases) occurs within 8 centimeters proximal to the RV shock coil, presumably due to increased stress from cardiac motion at this point.

Figure A. Riata lead with externalization of conductor cables

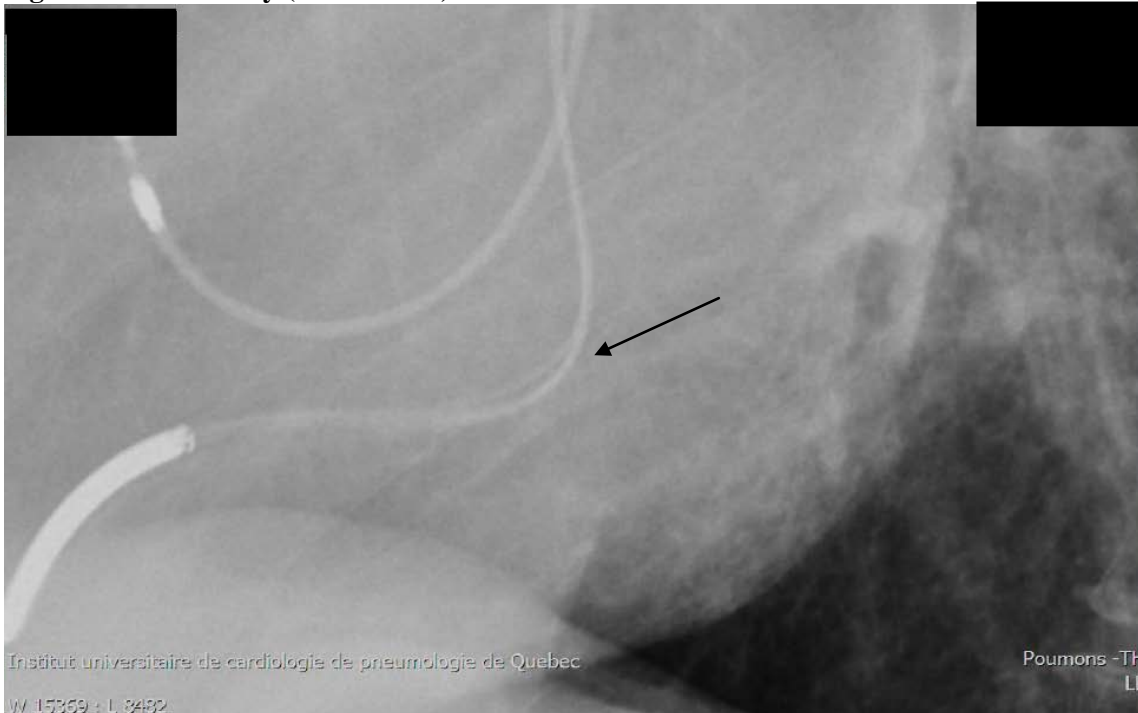
Figure B. Chest Xray (lateral view) of Riata lead with externalization of conductor cables

3. The CHRS-DC does not recommend lead replacement for this issue unless abnormal electrical parameters are identified.
4. Routine screening with fluoroscopy or high quality chest radiographs from multiple angles may be useful in identifying an affected lead.*

5. The CHRS-DC does not recommend lead replacement for this issue at the time of system revision, but does recommend fluoroscopic screening at the time of system revision to identify an affected lead.* If found, consideration to lead revision should be given to a lead revision procedure, guided by the risk/benefit of doing so in that individual situation. Lead extraction for the affected lead should be considered, again guided by risk/benefit analysis, as there is possibility of further degradation of the ETFE around the lead, with resultant possibility of a short-circuit between the new high voltage lead and the retained lead with exposed conductors.
