## **Canadian Heart Rhythm Society Device Committee**

### **RE: ADVISORY – Boston Scientific Minute Ventilation oversensing advisory**

## Important Medical Device Information

## Appendix A: Description of Minute Ventilation for the December 2017 MV Product Advisory

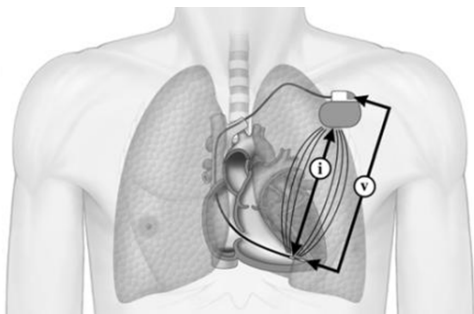
Boston Scientific pacemakers use transthoracic impedance to measure MV which is a product of respiration rate and tidal volume. During inhalation, the increased volume of air in the chest cavity produces an increase in transthoracic impedance. Likewise, during exhalation, the decreased volume of air produces a decrease in transthoracic impedance. Transthoracic impedance measurements are obtained through delivering a subthreshold current waveform approximately every 50 ms between the lead ring electrode and the pacemaker case, and measuring the resultant voltage between the lead tip and the pacemaker case (Figure 1). Boston Scientific pacemakers use the MV sensor for RightRate™ (rate adaptive pacing), Respiratory Rate Trend, and AP Scan™<sup>6</sup>.

Figure 1. Measurement of the MV Signal from the RV lead

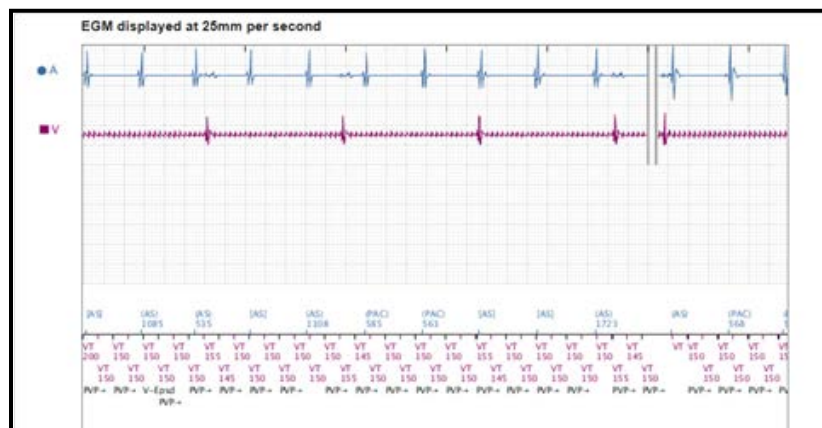
Engineering analysis and testing, as well as evaluation of post-market surveillance data, demonstrates an elevated potential for oversensing of the MV sensor signal in certain pacemaker systems connected to Medtronic or Abbott pacing leads. Although all leads evaluated in simulated testing environments comply with appropriate connector standards<sup>3</sup>, we have discovered subtle differences amongst lead manufacturers in the surface finish of the lead terminal ring and amount of axial and radial terminal ring motion within the pacemaker header. These factors may result in intermittent increases in impedance leading to oversensing of the MV sensor signal or changes in daily impedance test measurements.

Boston Scientific pacemakers perform an MV lead check approximately every hour to assess lead and lead connection integrity. The active vector may be the primary vector (distal RA ring electrode to the pacemaker case) or secondary vector (distal RV ring electrode to the pacemaker case). Since either vector may be used to measure MV, at least one of the implanted leads must have normal bipolar lead impedances. Typically the MV sensor signal is appropriately filtered out by the pacemaker. However, if a high impedance condition is detected within the lead-pacemaker system, the MV sensor signal may be oversensed (Figure 2).

Figure 2. Example of MV signal oversensing

- For pacemaker-dependent patients, turn the MV sensor “OFF”. Note when programmed to passive, the MV sensor signal is enabled and may be oversensed. See Appendix B for details on turning the MV sensor “OFF”.

- In accordance with the pacemaker manual, if MV sensor signal artifacts are observed on EGMs and leads are performing appropriately, consider programming the sensor to “OFF” to prevent oversensing.
