## **Canadian Heart Rhythm Society Device Committee**

**RE: ACCOLADE, PROPONENT, ESSENTIO, and ALTRUA 2 dual chamber (DR) standard life (SL) and extended life (EL) pacemakers; and VISIONIST and VALITUDE cardiac resynchronization therapy pacemakers (CRT-Ps) with an increased potential to initiate Safety Mode during telemetry or other normal, higher-power operations due to high battery impedance**

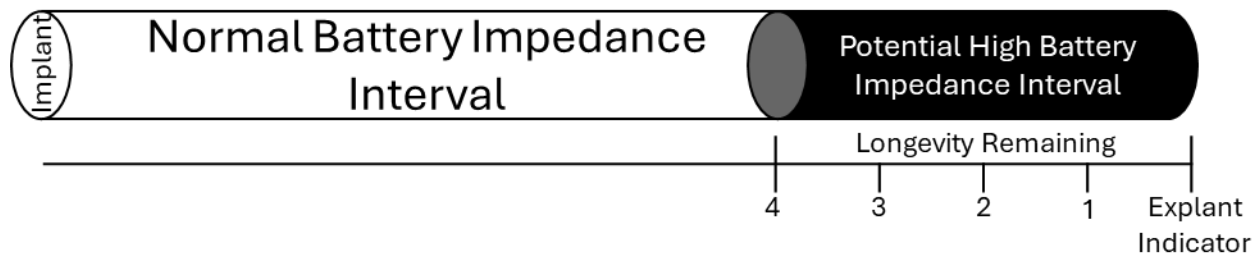
*Prophylactic*. General prophylactic replacement is not recommended. For patients with a device from the advisory population AND who are at risk of harm due to non-programmable parameters in Safety Mode, schedule device replacement promptly when the longevity remaining reaches four (4) years or if the longevity remaining is already less than 4 years.

If the device reaches the potential high battery impedance interval before the next scheduled follow-up, schedule an appointment with your patient prior to that interval to discuss management options using a shared decision-making approach.
